**Re: 11 Highfield Street, Earl Shilton LE9 7HS**

Following my inspection of the above property in connection with Rising Damp, I would report as follows:-

#### **RISING DAMP**

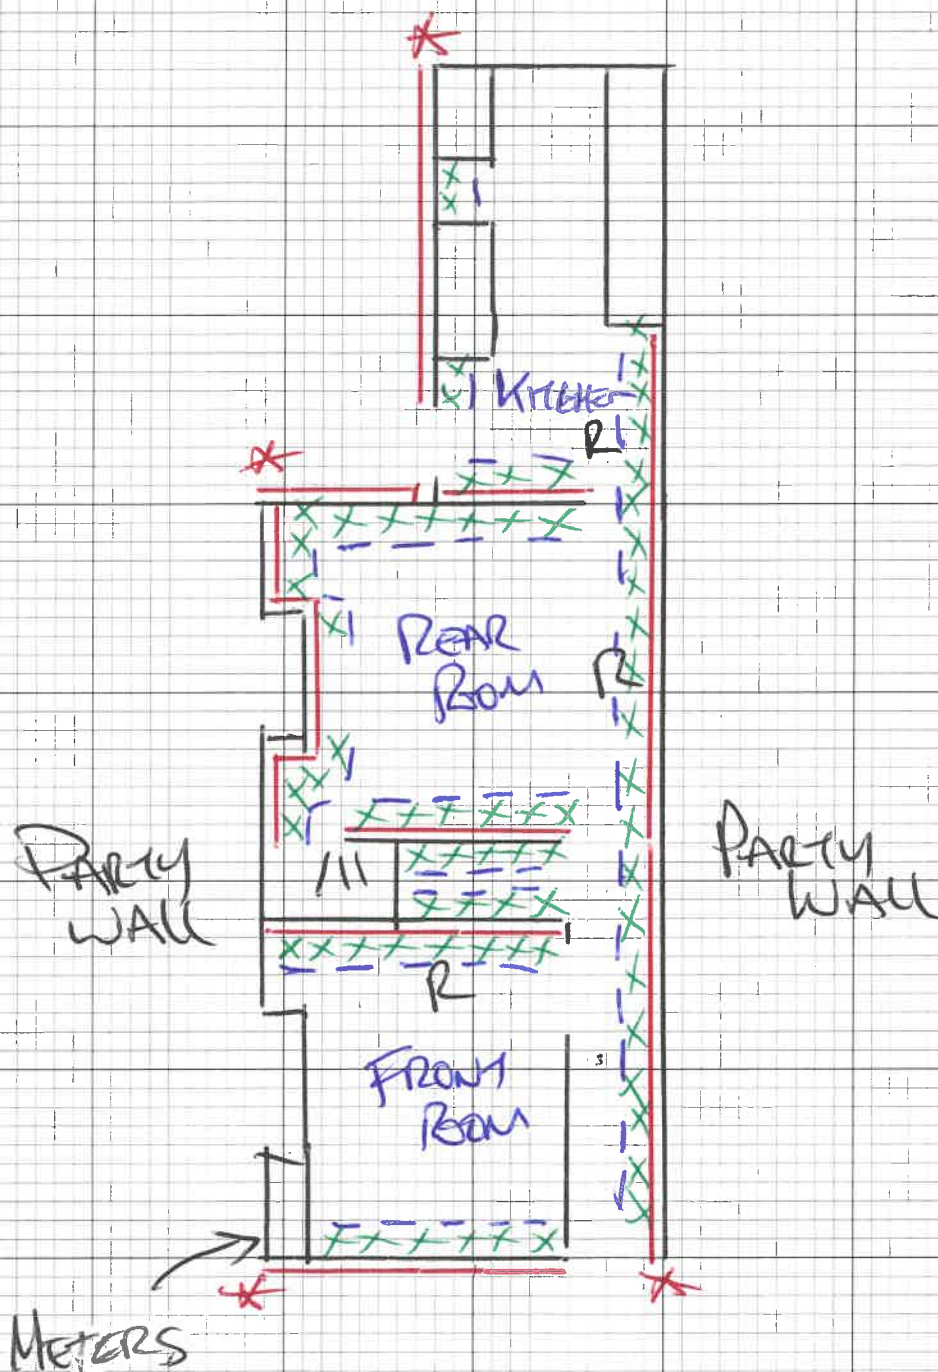
xxx = SALT MEMBRANE  
R = RADIATOR

ALL INTERNAL WALLS ARE 112mm THE REMAINING ARE 225mm UNLESS STATED

MOISTURE CONTENT %  
HORIZONTAL DPC \_\_\_\_\_

VERTICAL DPC  
REPLASTER TO 1 METRE \_\_\_

\* VERTICAL TANKING  
CHANGE IN FLOOR LEVEL ~~~

- 1 Insert a new chemical damp proof course to the walls detailed below using an environmentally friendly cream based system injected into the mortar joints.

Front room front external wall  
Front room party wall with stairs  
Hall party wall with adjoining property, right side  
All walls of the rear room  
Kitchen party wall with adjoining property, up to the fitted units  
Kitchen side external wall  
Including suitable verticals
