# **Webb Structural Design Ltd**

## **Part Structural Inspection of 8c & 12 Thornfield Way Hinckley. LE10 1BE**

**For: Mr & Mrs Grewcock**

**Conducted by: Craig Webb**  
**On: 7<sup>th</sup> April 2017**

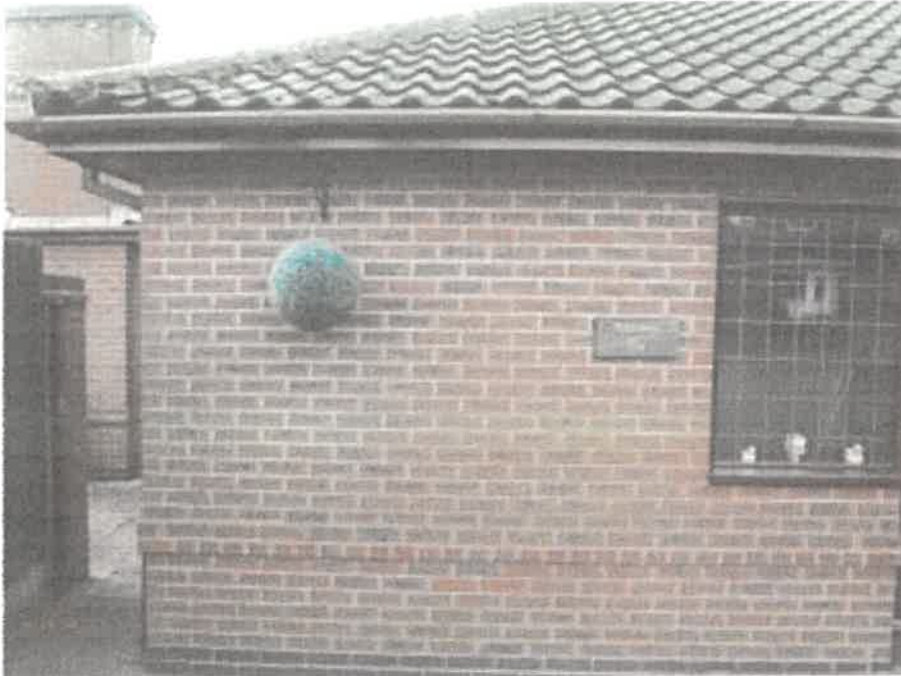
An inspection was made of the external walls of the main house and garage area. No cracking or signs of structural movement were noted. All of the facing brickwork was noted to be in very good condition. The walls are plumb with no bowing present.

Photograph 1 – Front LHS wall elevation

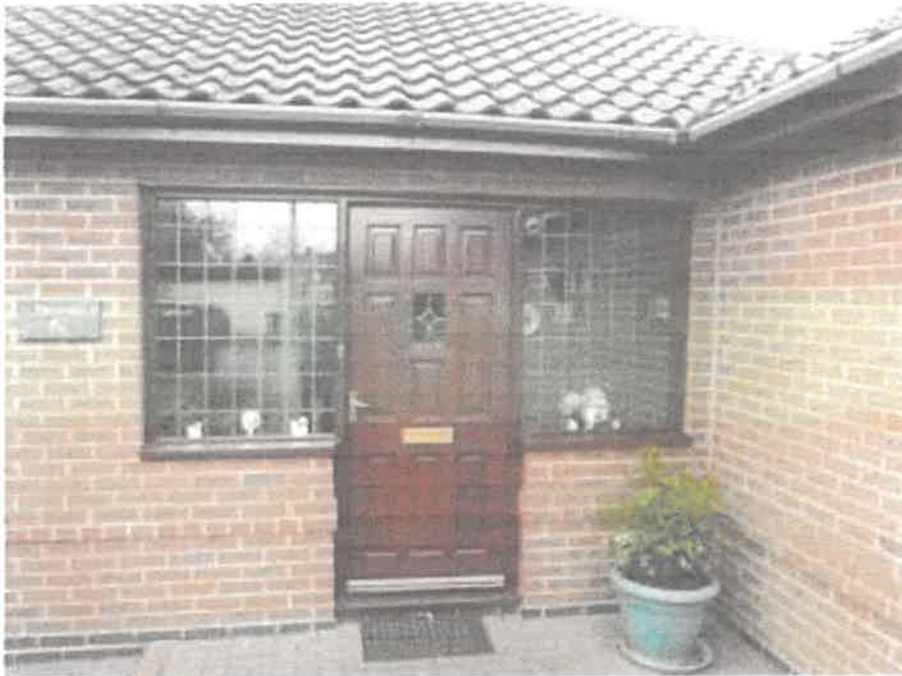
**Photograph 2 – Front RHS wall elevation**

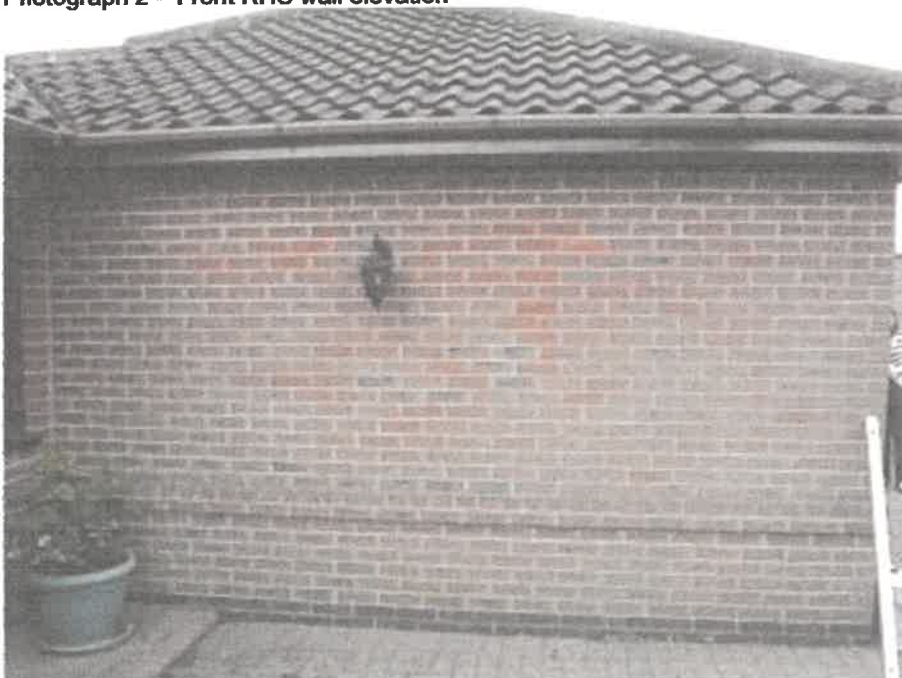
**Photograph 3 – Garage LHS gable wall**

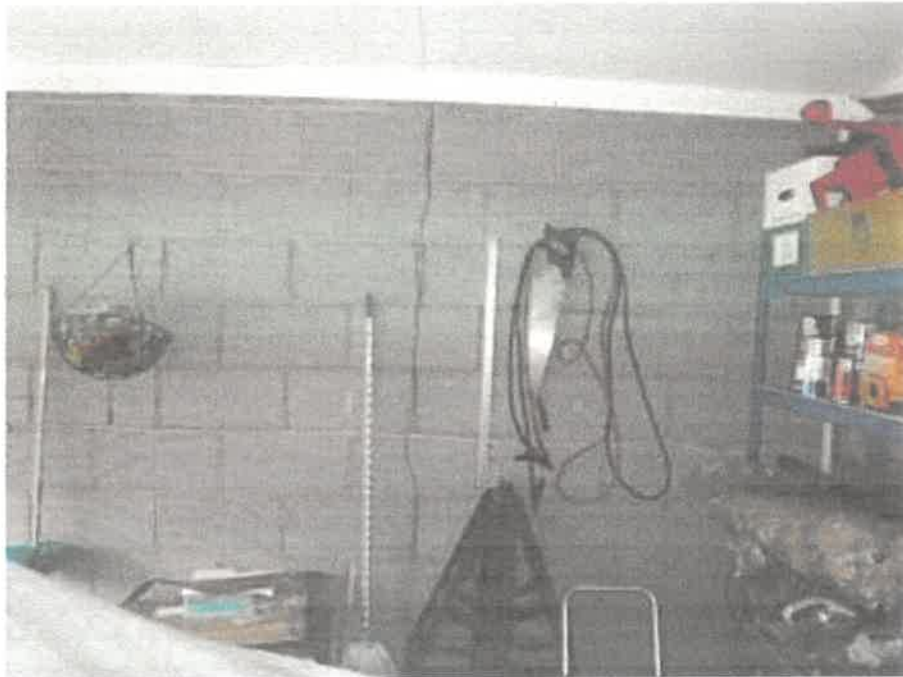
An inspection was made within the double garage. The internal walls of the garage are plain unpainted blockwork. Vertical cracking to the blockwork was noted to the LHS gable wall. Three cracks are present to this wall, running from floor to ceiling. The cracks are spaced evenly with one near the front corner, one in the middle and one near the rear corner. The two front cracks are hairline in nature. The rear crack has a width of 5mm in the worst case. Similar cracking is present to the RHS gable wall, although a window is present to this elevation. Cracking is present above and below all four window corners. A further vertical

**Photograph 4 – Worst of cracking to rear of LHS gable wall**

The cracking noted to the garage of number 8c is not due to subsidence. The cracking is related to blockwork shrinkage. The masonry has dried out since construction and shrunk laterally. This has allowed vertical cracks to form at regular centres. The external masonry is in very good order and unaffected by this issue. The cracks should not progress any further in length or width. The cracks could be raked out and re-pointed if required (allow a cost of £500-£750+vat for this work).

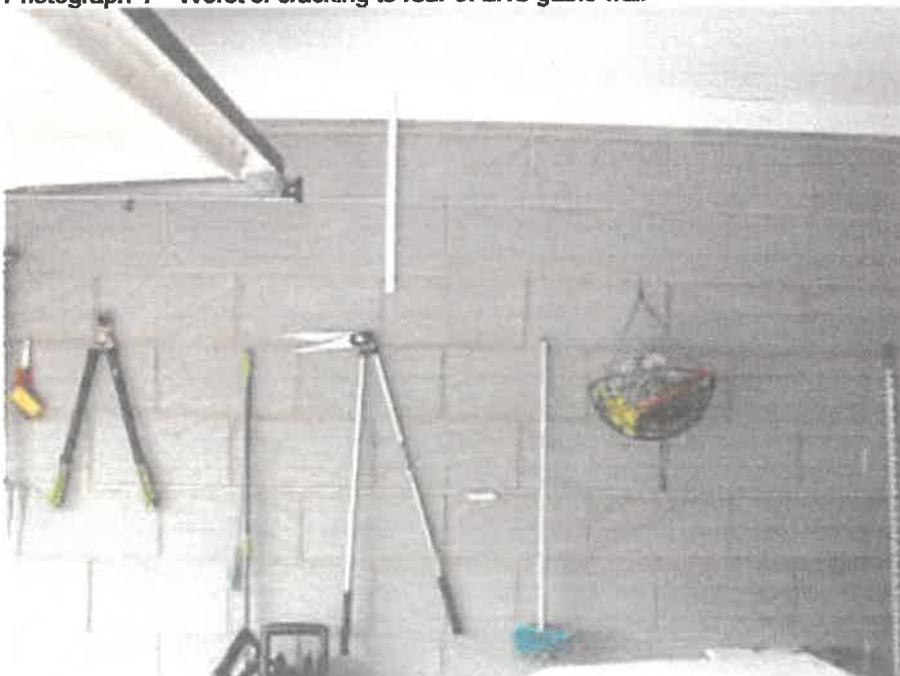
**Photograph 5 – Hairline cracking to middle of LHS gable wall**

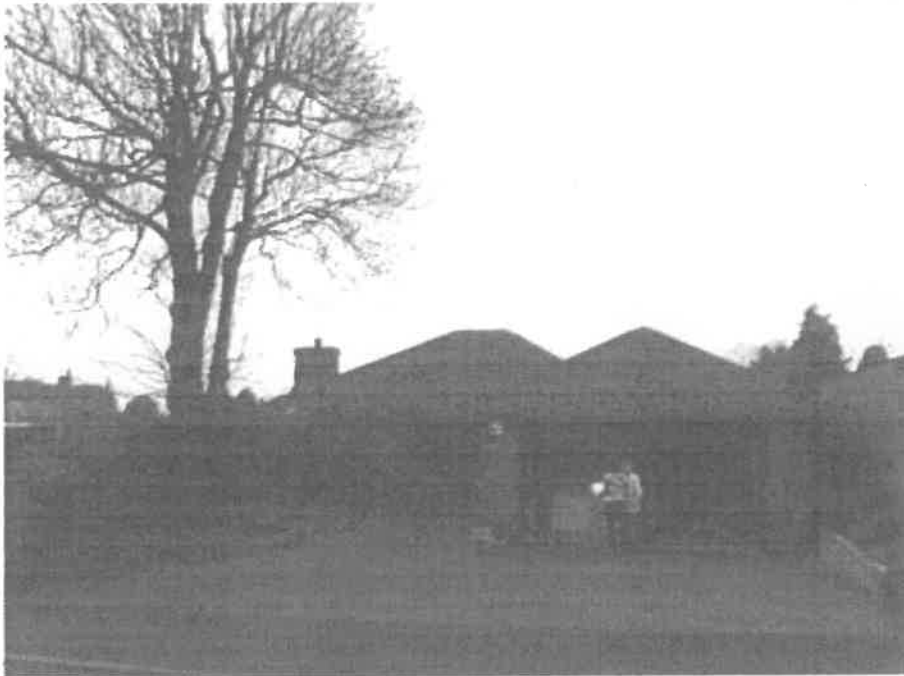
The front and side garden of the property is finished in block paving. A small flower bed is present around the tree location on the LHS. The block paving is generally in good order. Around the tree location, a number of blocks were noted to have been pushed upwards by the tree roots. The owner stated that they have previously re-laid this area of paving due to the roots lifting the surface.

**Photograph 6 – Front garden elevation**

The block paving to the front garden will be subject to local movement caused by the tree roots. There is not much that can be done to avoid this issue. When the situation occurs, the paving can be locally lifted and re-laid as required.

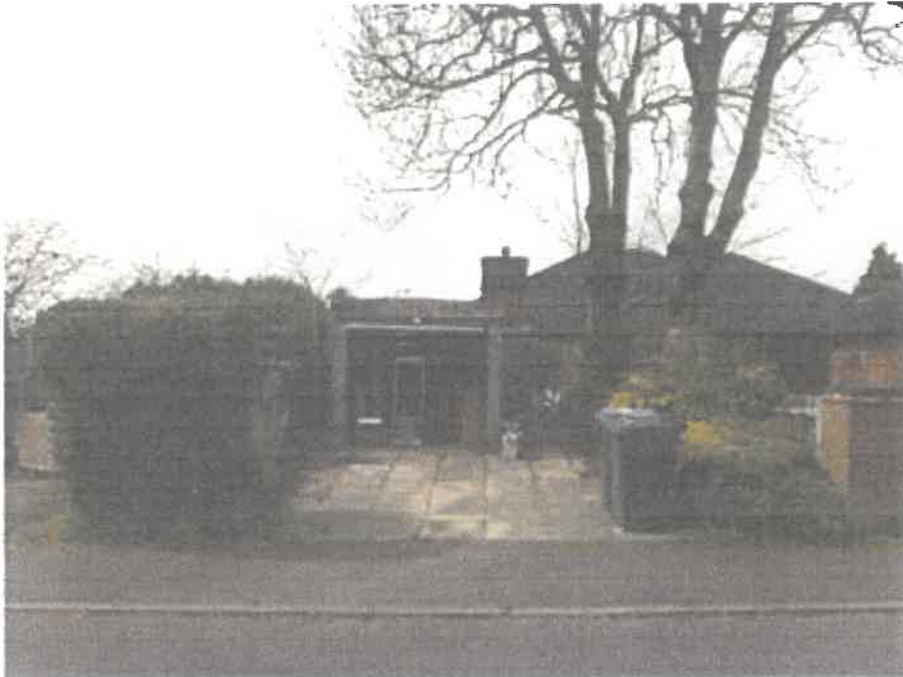
The garage structure to number 12 was noted to be approximately 1.5m from the Ash tree and 2m from the Sycamore. The garage was full of stored items at the time of the survey and only a limited inspection

**Photograph 8 – Elevation of tree and garage**

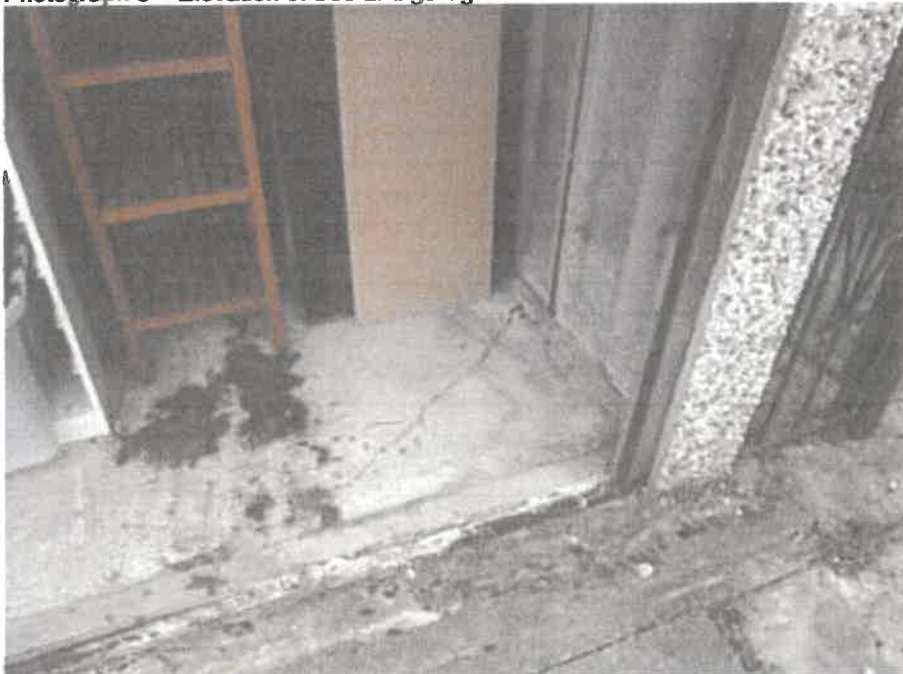
The visible area of the garage floor slab was noted to have some cracks present. A large crack was noted to the front RHS corner of the slab.

**Photograph 9 – Cracking to front of garage slab**

The garage to number 12 is close to the existing trees. It is clear that large tree roots are running under the garage floor slab and disturbing the paving locally. The paving slabs can be locally re-laid to take account of the existing roots. Periodic works will be needed to this area to maintain a level floor. The garage floor slab is most likely a thin slab construction, without any structural reinforcement. In this situation, cracks are inevitable. The existing cracks are unlikely to progress much further, but they may get worse during a long dry spell and then close up slightly in the winter months. To resolve the issue would require the removal and relaying of the floor slab. A 150mm thick concrete slab with reinforcement would suffice to prevent future cracking. However, given the closeness of the trees, the slab could still move and rotate as a whole under the influence of the trees. If a new masonry based garage is to be constructed in this area, it is recommended that the foundations are mini-piled to avoid such issues.

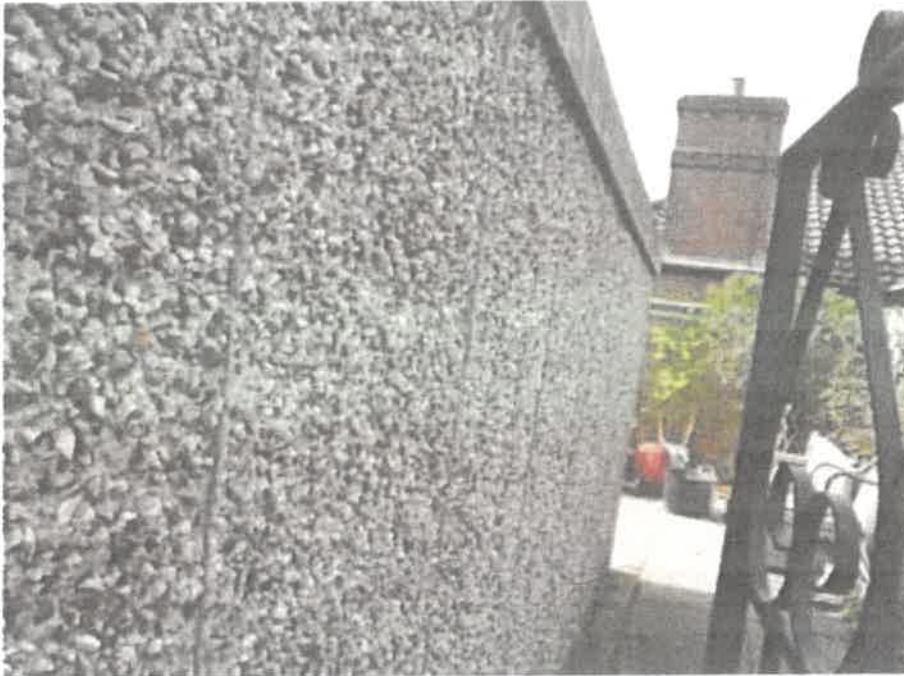
internally could be conducted. The concrete panel walls were noted to be in good order. No cracking or signs of spalling were noted. The RHS gable wall was noted to be slightly out of plumb.

**Photograph 10 – RHS gable wall to garage**

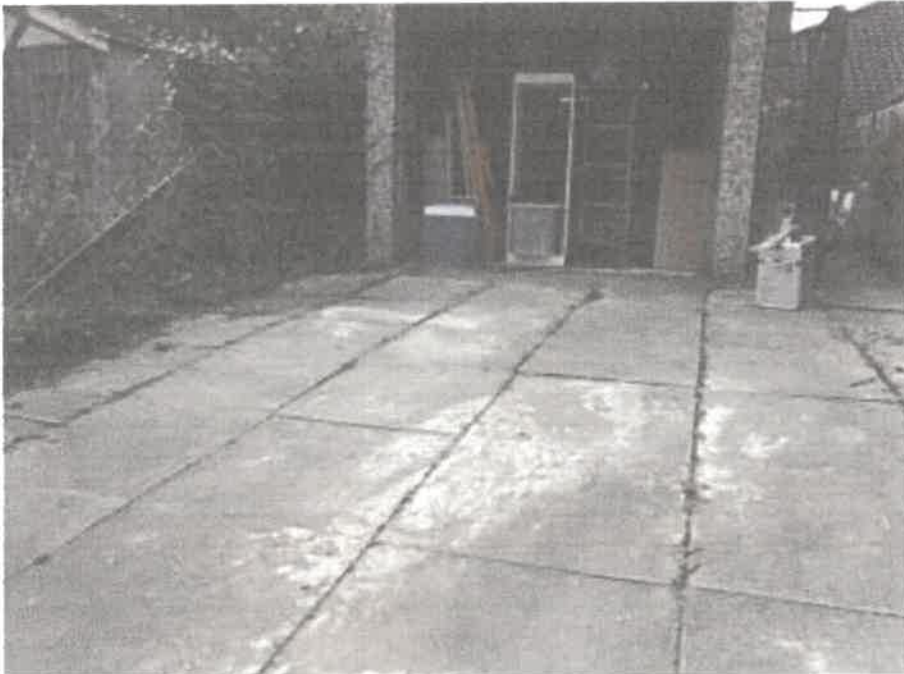
The paving slabs to the front of the garage were noted to be generally level and in good order. Occasional unevenness was noted, but not to an excessive degree. The slabs to the RHS of the garage were noted to be uneven. Immediately next to the tree trunk, the paving slabs have lifted to a notable degree.

**Photograph 11 – Slightly uneven slabs to front of garage**

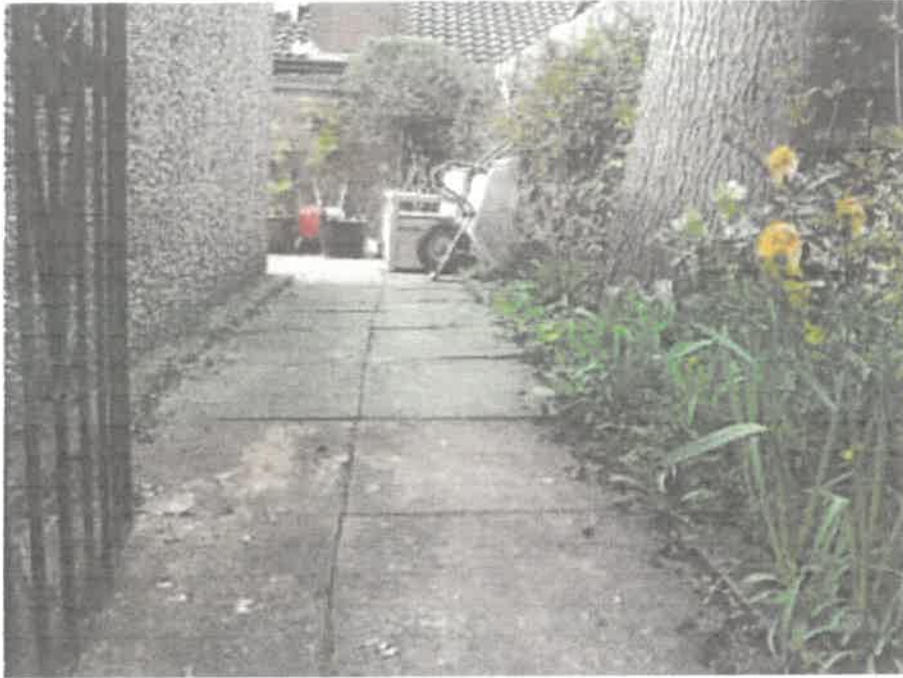
Photograph 12 – Raised slabs near tree trunk
